# Manhole Inspection Summary

Manhole # S3301\_018MH

Insp Date: **2/4/08 1:53 PM**

**Location** Address: **3032 Ascension St**

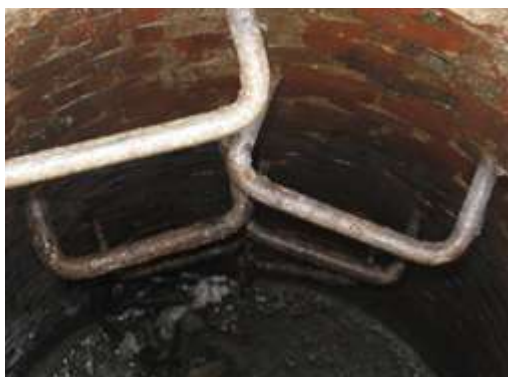
steps

Count: **8** Missing: **0** ☐ Corroded

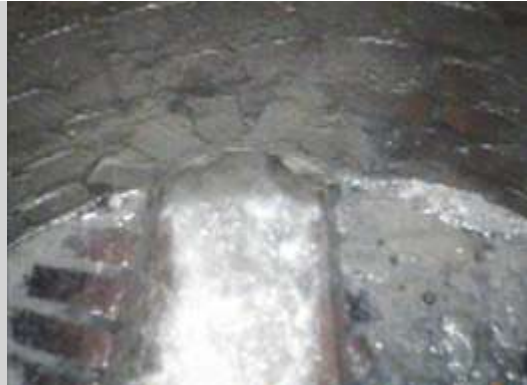
12 O'Clock Outflow

10 in. Circular Gravity Sewer  
Pipe Out @ 12 O'Clock

Pipe Height: **12** (in.) Rod and Bar (Angled)  
Pipe Material: **Clay** ☐ Pipe Lined  
Invert Depth: **12.58** (ft.) Flow Characteristics: **Fast**  
Deposits: ☒ None ☐ Mud ☐ Sludge ☐ Debris ☐ Grease  
Silt Depth: (in.) Deposits Extent:  
Infiltration: **None** Pipe Seal Cond: **Sound**

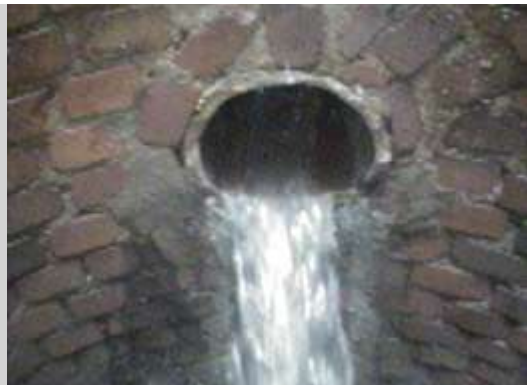
6 O'Clock Inflow

8 in. Circular Gravity Sewer  
Pipe In @ 6 O'Clock

Pipe Height: **9.6** (in.) Rod and Bar (Angled)  
Pipe Material: **Clay** ☐ Pipe Lined  
Invert Depth: **9.42** (ft.) Flow Characteristics: **Fast**  
Deposits: ☒ None ☐ Mud ☐ Sludge ☐ Debris ☐ Grease  
Silt Depth: (in.) Deposits Extent:  
Infiltration: **None** Pipe Seal Cond: **Sound**

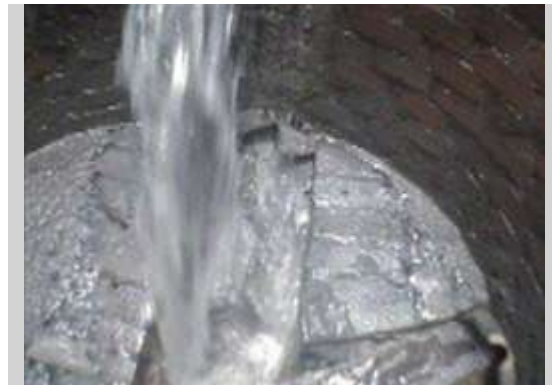
Drop In @ 6 O'Clock

Drop: **Inside** Rod and Bar  
Angled: **Yes** Reading: **11.04** (ft.)  
Inv Depth: **12.04** (ft.)  
Drop Condition: **Open**

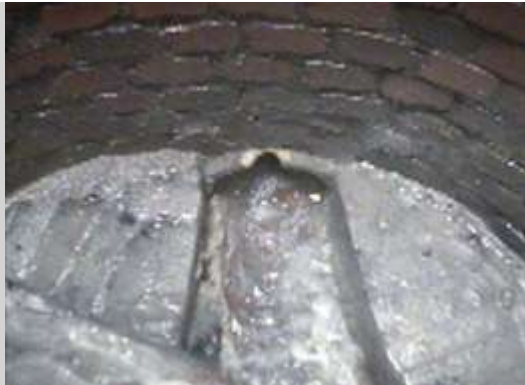
8 O'Clock Inflow

8 in. Circular Gravity Sewer

Pipe In @ 8 O'Clock

Pipe Height: **10.8** (in.) Rod and Bar (Angled)

Infiltration: **None** Pipe Seal Cond: **Sound**
